Face milling of nickel-based superalloys with coated and uncoated carbide tools

**FACE MILLING OF NICKEL-BASED SUPERALLOYS WITH
COATED AND UNCOATED CARBIDE TOOLS**

**A thesis submitted in partial fulfilment of the University's requirements
for the award of the Degree of Doctor of Philosophy**

SYNOPSIS

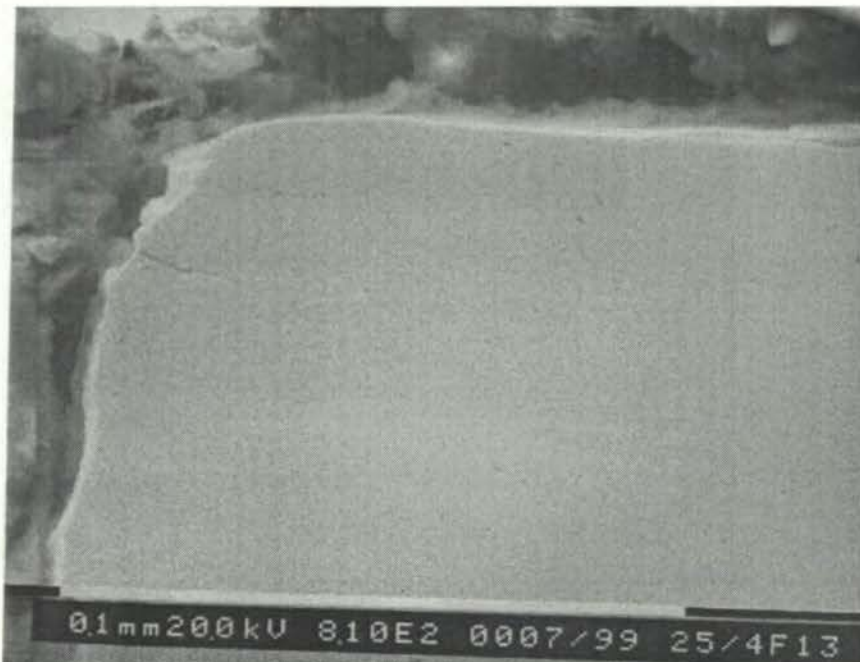
Figure 7. 123 Sectioned KC730 tool showing plastic deformation on the rake face and propagated cracks from the chipped area on the flank, after cutting Waspaloy for 13 seconds at 100 m/min and 0.08 mm/tooth

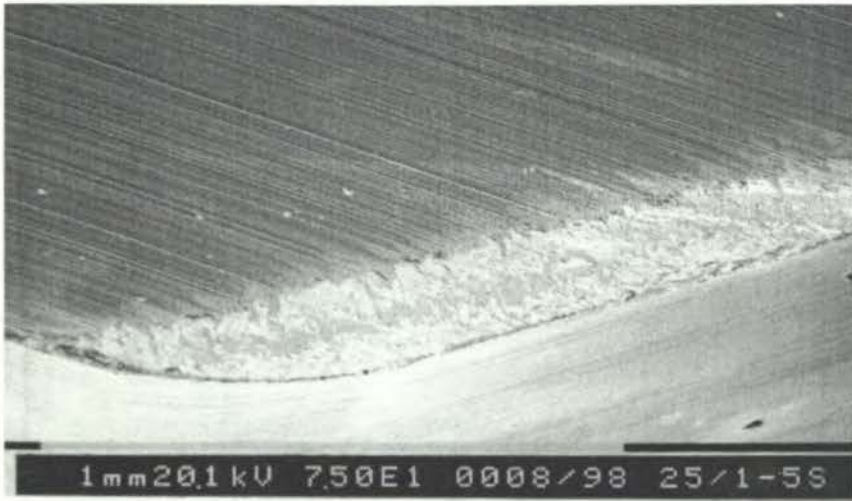
Figure 7. 127 Early coating delamination and galling on KC730 tool after 5 seconds when machining Waspaloy at 25 m/min and 0.08 mm/tooth

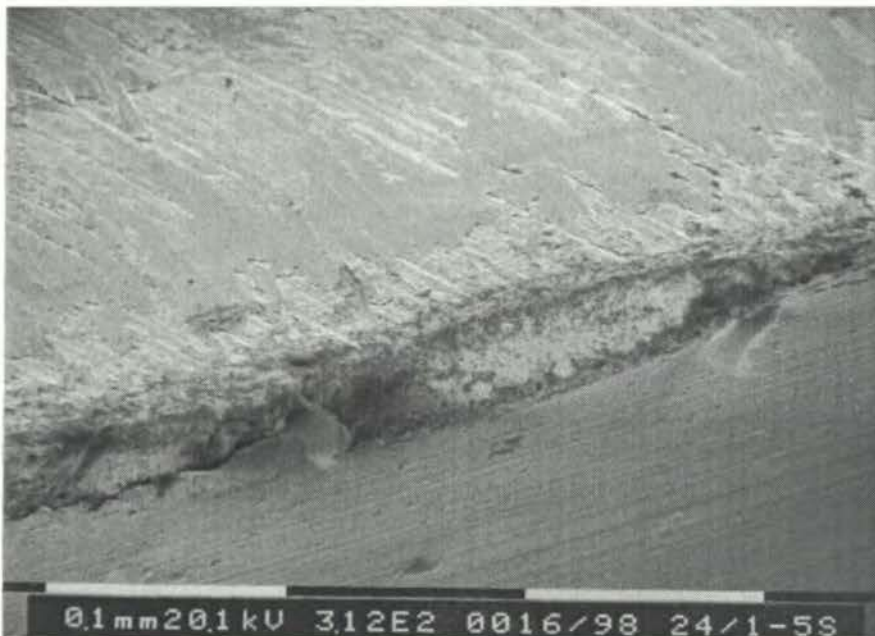
Figure 7. 128 Premature microchipping, coating delamination and galling on KC730 tool after 5 seconds of machining Waspaloy at 25 m/min and 0.14 mm/tooth

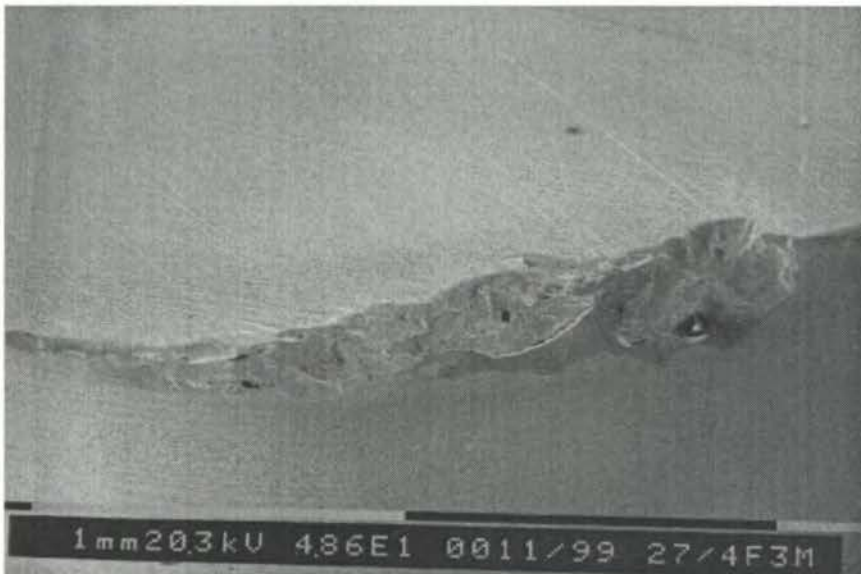
Figure 7. 133 Severe chipping on a failed KMF tool after cutting Waspaloy for 3 minutes at 50 m/min and 0.08 mm/tooth

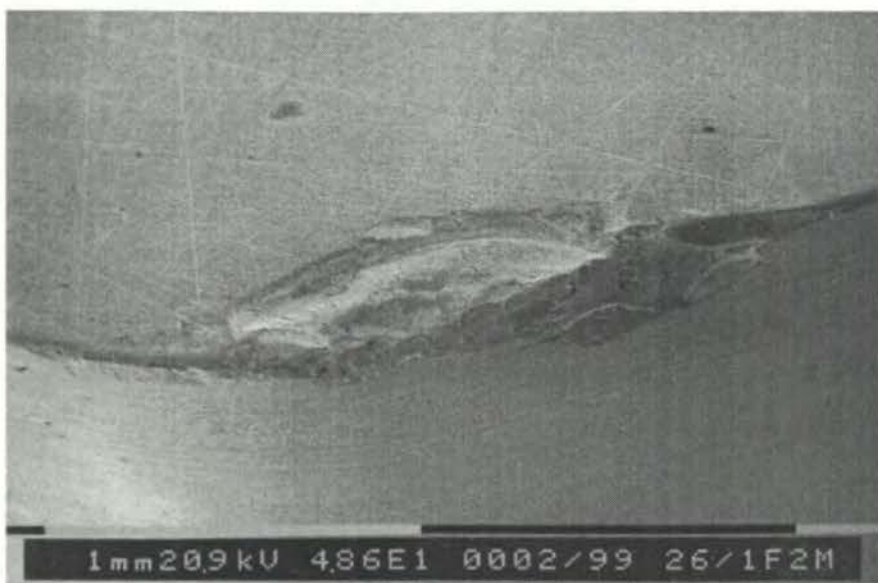
Figure 7. 134 Catastrophic failure of a KMF tool after cutting Waspaloy for 2 minutes at 25 m/min and 0.14 mm/tooth

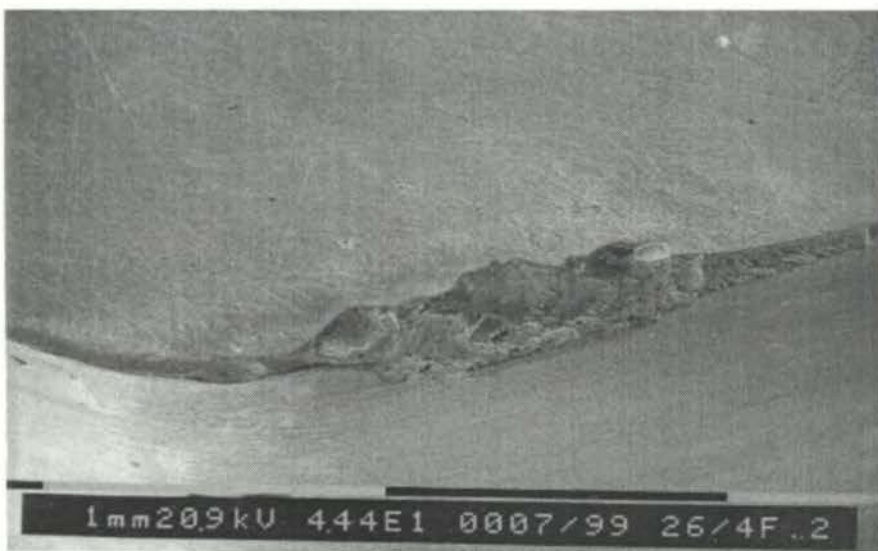
Figure 7. 135 Premature failure due to severe breakage on a KMF tool after 15 seconds when machining Waspaloy for at 50 m/min and 0.14 mm/tooth

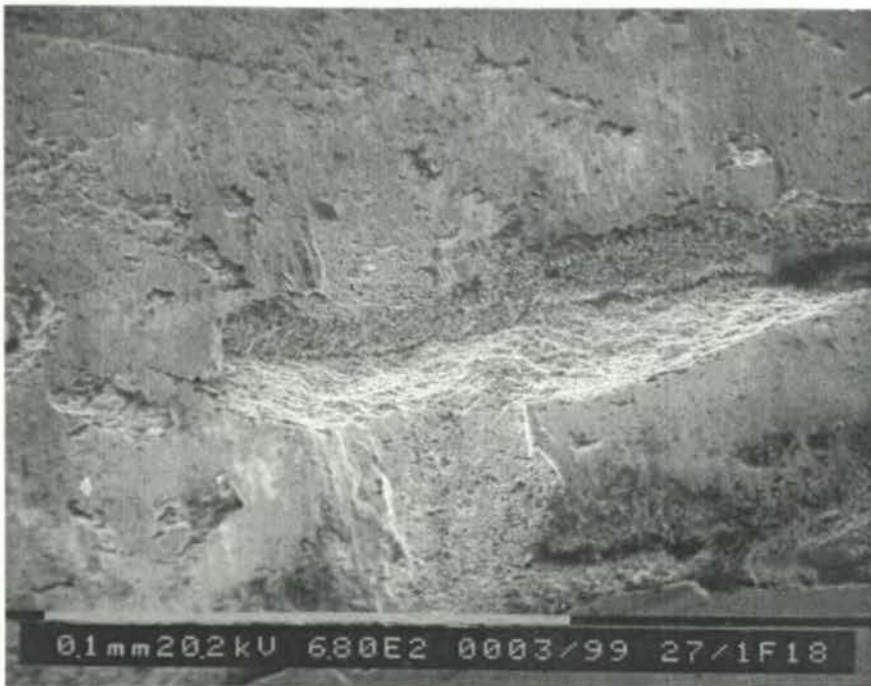
Figure 7. 136 Magnified view of the failed KMF tool in Figure 7.132 showing flaking and associated cracking on the rake face

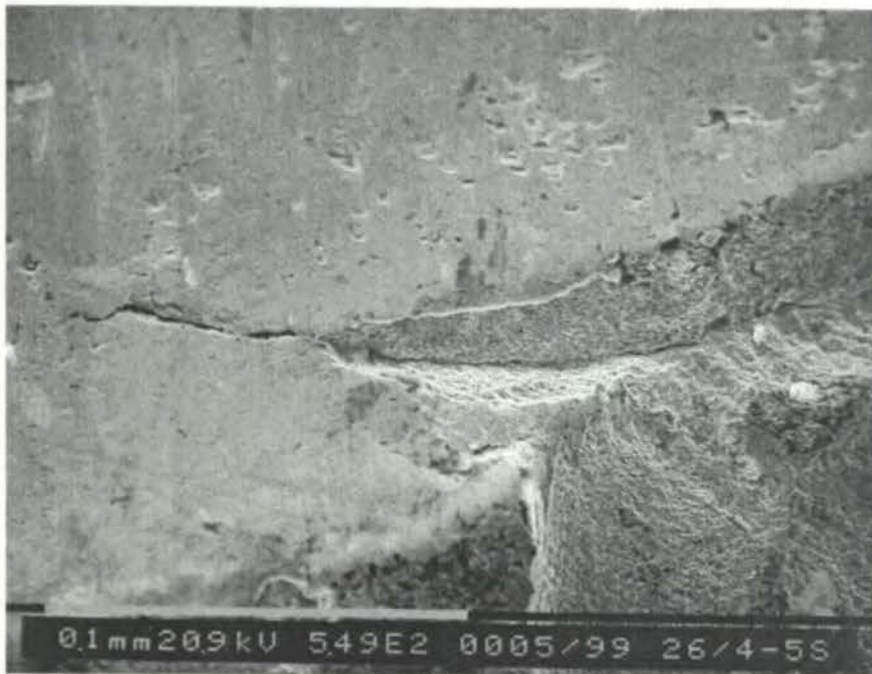
Figure 7. 140 Enlarged view of a fractured area with crack on a KMF tool after 5 seconds of cutting Waspaloy at 50 m/min and 0.14/tooth

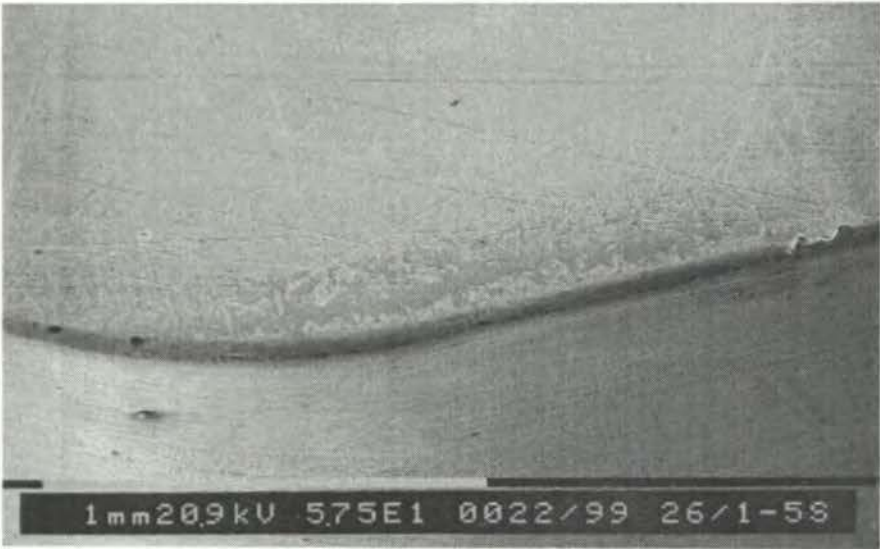
Figure 7. 143 Overall view of a KMF tool showing initial workpiece adhesion and pitted rake face after machining Waspaloy for 5 seconds at 25 m/min and 0.14 mm/tooth

Figures 7.143 to 7.148 show the presence of workpiece galling and substrate pitting and chipping at various cutting conditions. At the lowest cutting speed of 25 m/min, workpiece adhesion at tool-chip contact zones and associated rake face pitting were dominant for high and low feed rates as shown in Figures 7.143 to 7.145. Figures 7.147 and 7.148 suggest that microchipping and severe workpiece adhesion, mainly on the chipped areas, were prominent at the highest cutting speed of 50 m/min and feed rate of 0.08 mm/tooth. Increasing feed rate to 0.14 mm/tooth at the same cutting speed led to severe chipping and breakage, with attendant cracking of the entire cutting edge as shown in Figures 7.140 and 7.146.

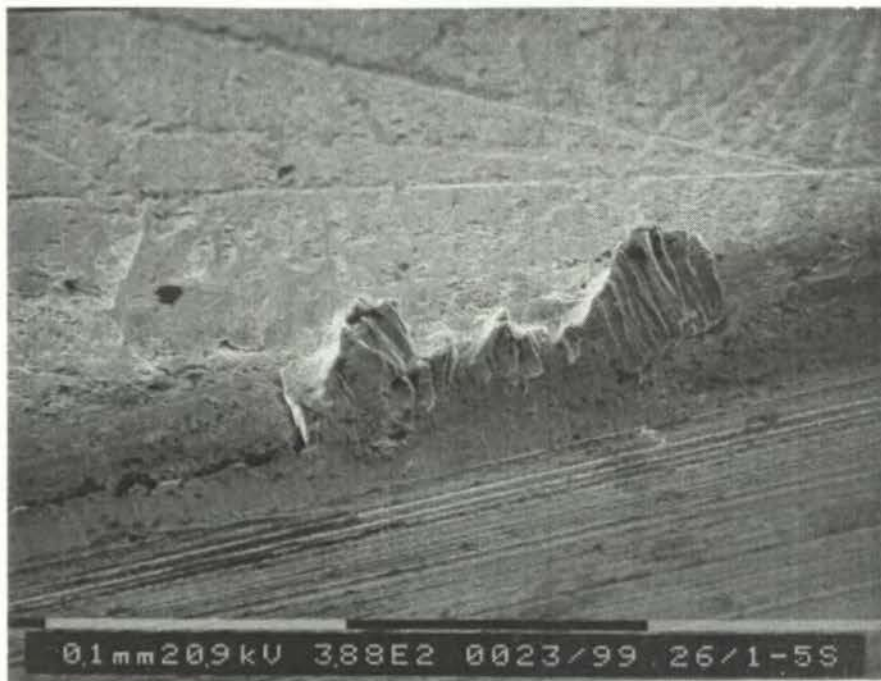
Figure 7. 144 Enlarged view of the KMF tool in Figure 7.143 showing adhered bulk of workpiece material and initial pitting on the rake

- Figure 7. 144 Enlarged view of the KMF tool in Figure 7.143 showing adhered bulk of workpiece material and initial pitting on the rake
- Figure 7. 145 Enlarged view of the KMF tool in Figure 7.143 showing pitted area caused by attrition after 5 seconds when machining Waspaloy at 25 m/min and 0.14 mm/tooth

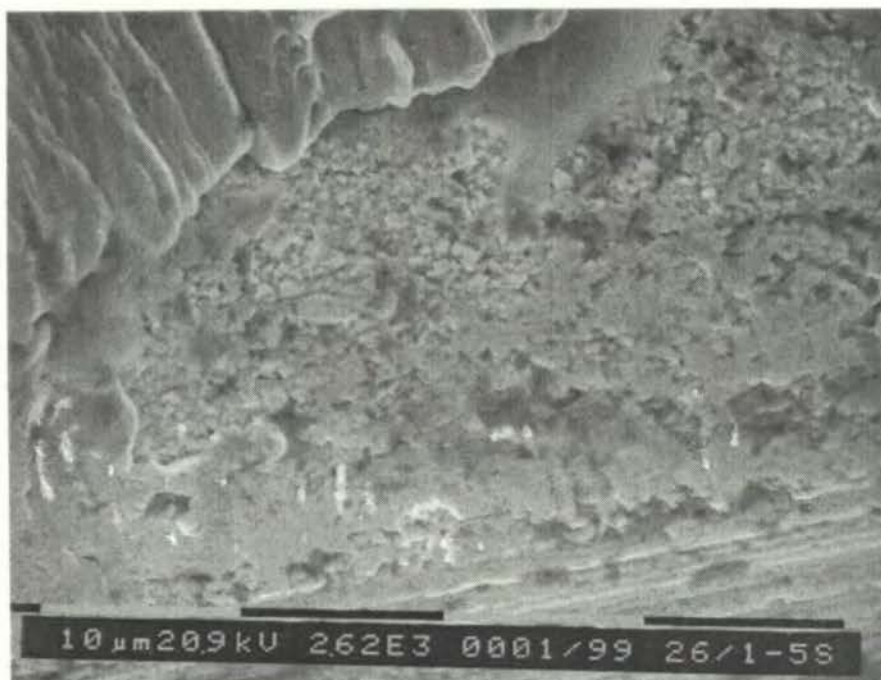
Figure 7. 145 Enlarged view of the KMF tool in Figure 7.143 showing pitted area caused by attrition after 5 seconds when machining Waspaloy at 25 m/min and 0.14 mm/tooth

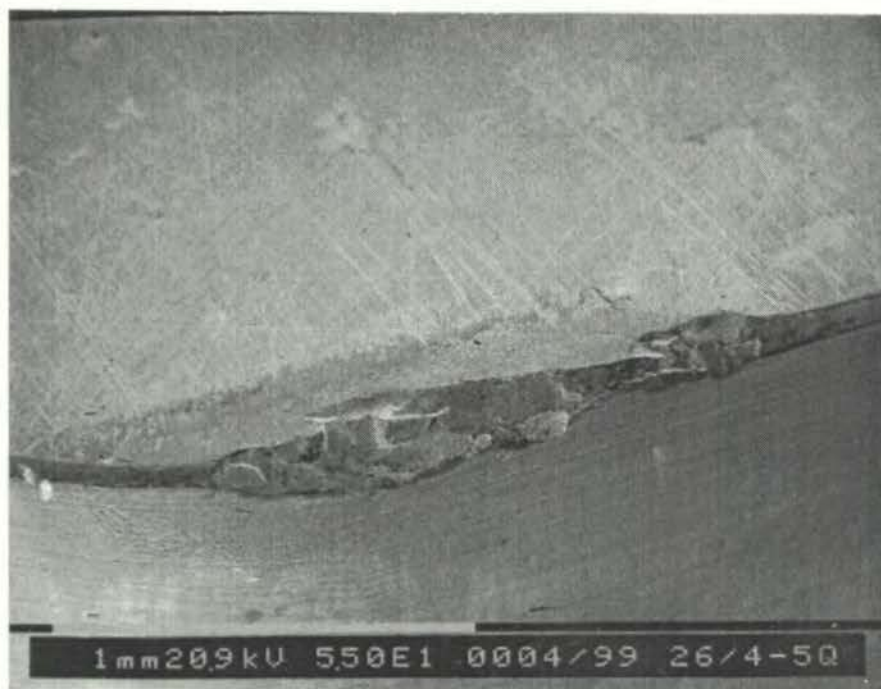
Figure 7. 146 Premature breakage of the entire cutting edge of a KMF tool after 5 seconds when machining Waspaloy at 50 m/min and 0.14 mm/tooth

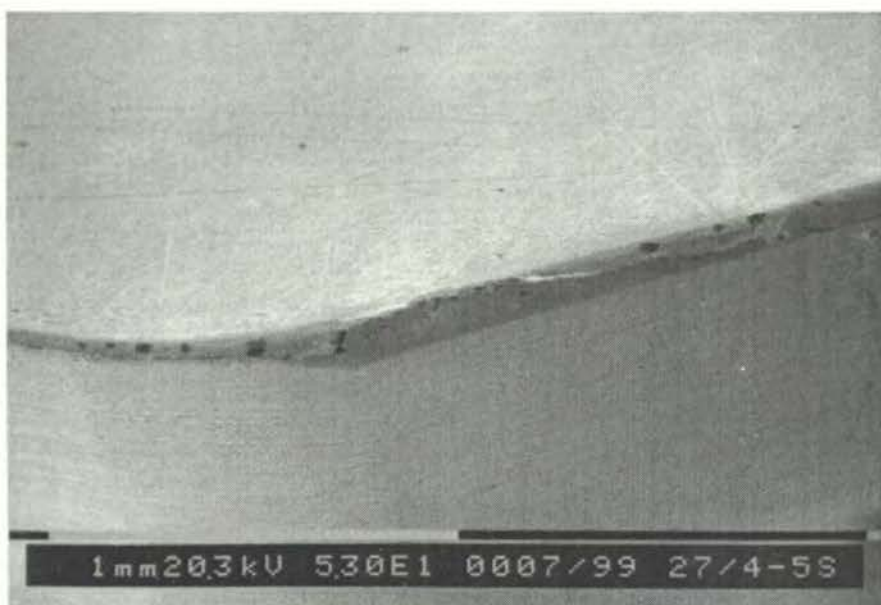
Figure 7. 147 Overall view of a KMF tool showing adhered bulk of workpiece material, most likely on microchipped chipped areas after machining Waspaloy for 5 seconds at 50 m/min and 0.08 mm/tooth

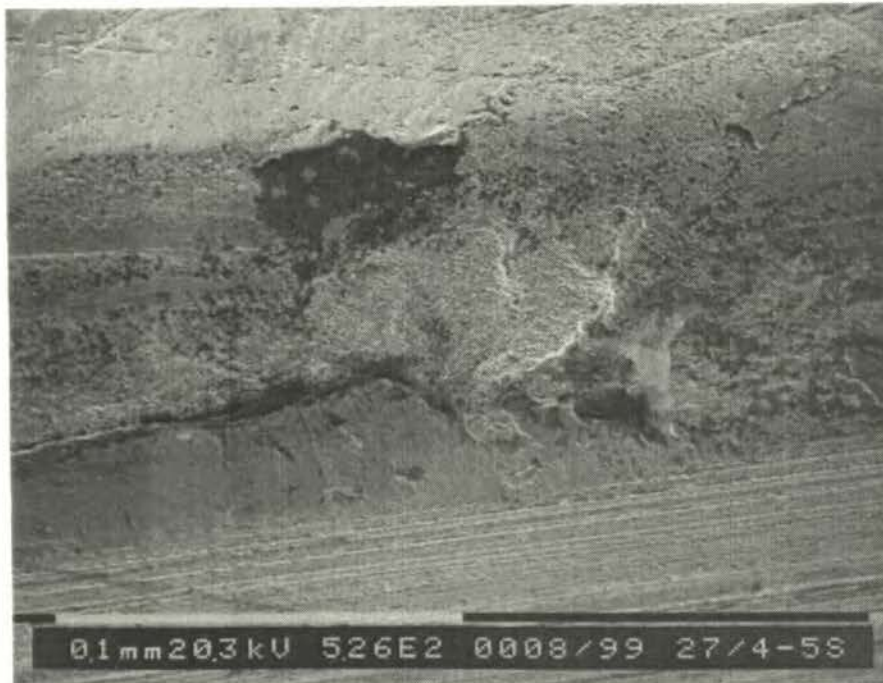
Figure 7. 148 Magnified view of the KMF tool in Figure 7.147 showing initial microchipping and workpiece adhesion after 5 seconds when machining Waspaloy at 50 m/min and 0.08 mm/tooth

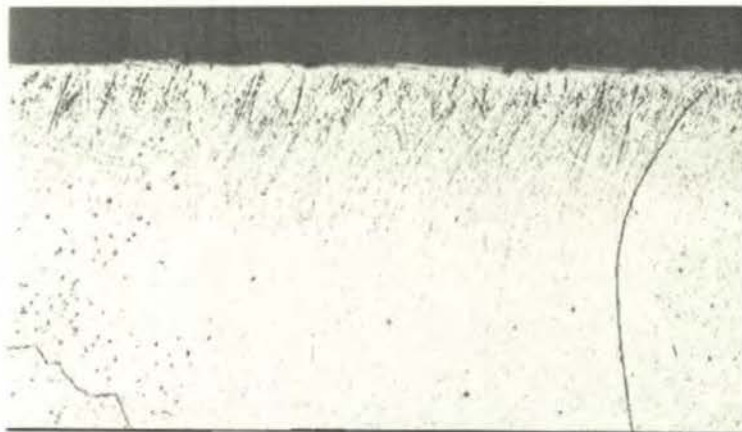
Figure 7. 165 Subsurface plastic flow and slight surface tearing after face milling Waspaloy with KC994M tool for 9 minutes at 25 m/min and 0.14 mm/tooth

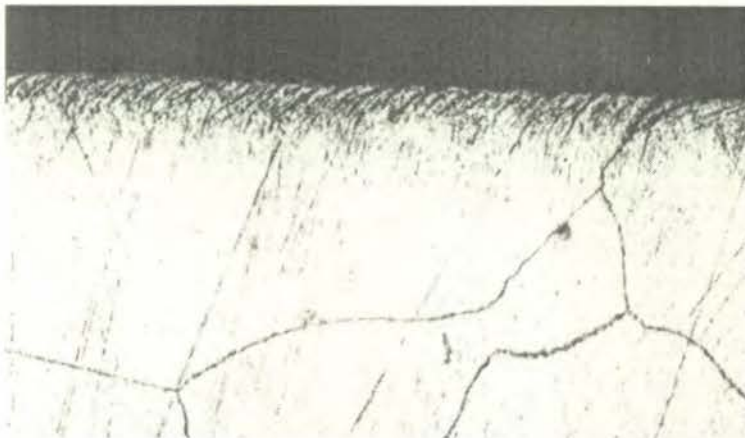
Figure 7. 168 Subsurface plastic flow after face milling Waspaloy with KC994M tool for 5 seconds at 25 m/min and 0.14 mm/tooth

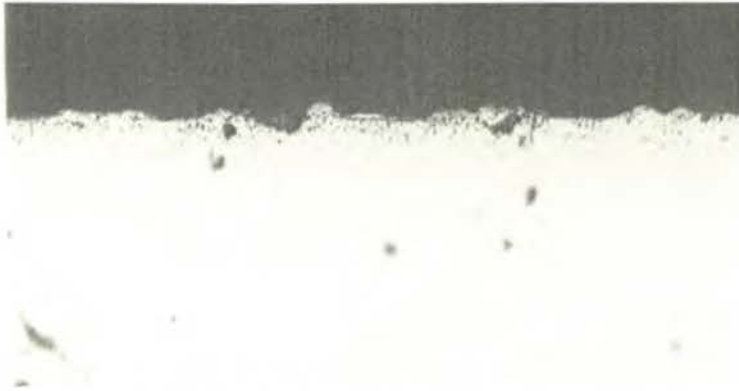
Figure 7. 169 Significant surface tearing after face milling Waspaloy with KC994M tool for 20 seconds at 75 m/min and 0.08 mm/tooth

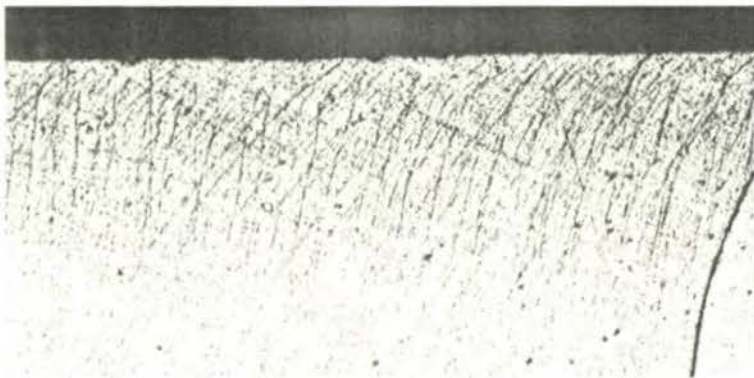
Figure 7. 170 Subsurface plastic flow after face milling Waspaloy with KC720 tool for 5 minutes at 25 m/min and 0.08 mm/tooth

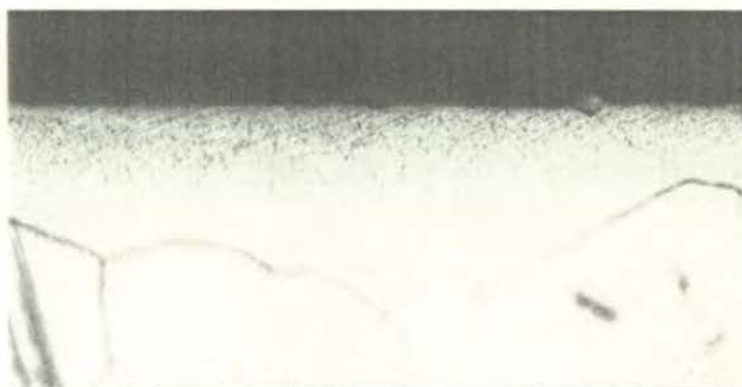
Figure 7. 174 Subsurface plastic flow and an embedded external particle into the surface layer after face milling Waspaloy with KC720 tool for 75 seconds at 50 m/min and 0.08 mm/tooth

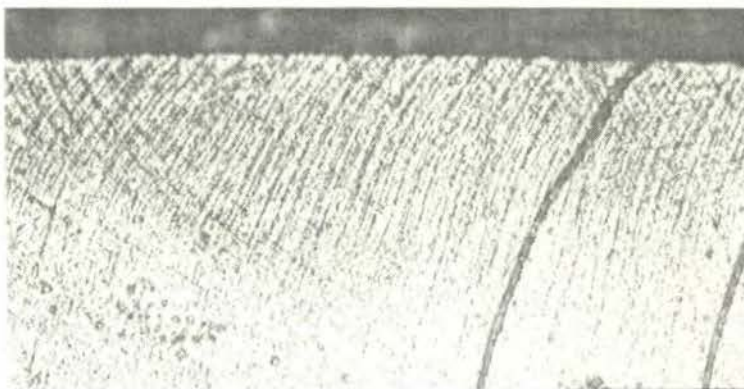
Figure 7. 177 Initial stage subsurface plastic flow after cutting Waspaloy with KC730 tool for 5 seconds at 50 m/min and 0.08 mm/tooth

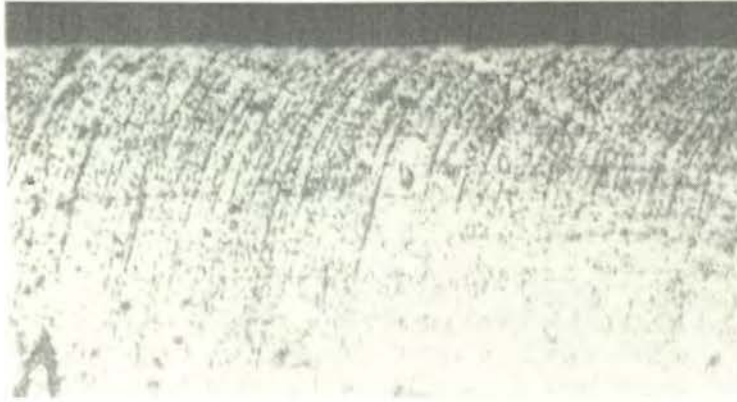
Figure 7. 178 Subsurface plastic flow after cutting Waspaloy with KC730 tool for 10 minutes at 25 m/min and 0.08 mm/tooth (1200X)

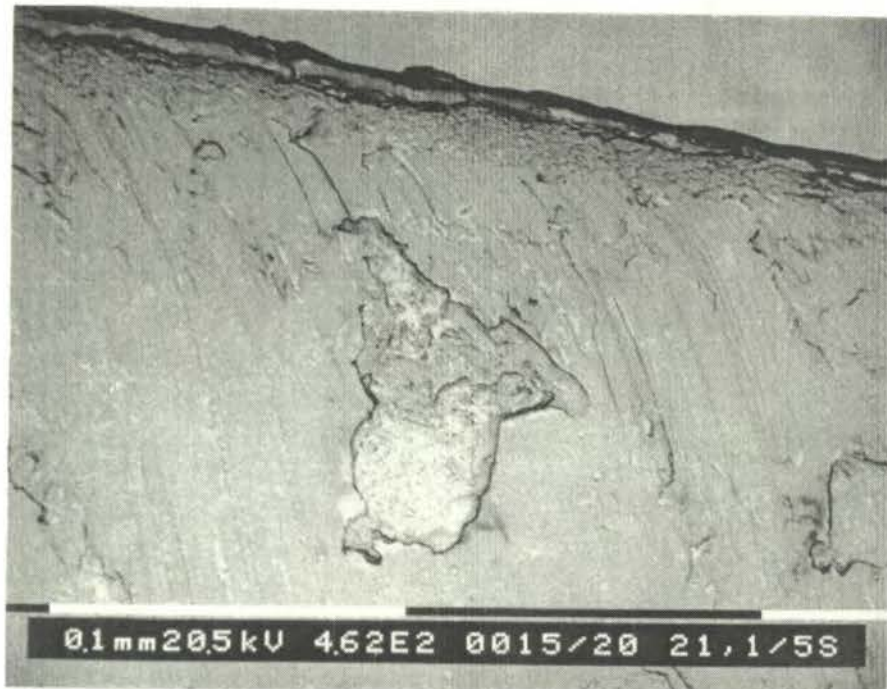
Figure 8. 4 (a) SEM micrograph showing stuck tool material to the root of a Waspaloy chip produced by KC994M tool after cutting for 5 seconds, (b) Corresponding EDAX analysis proving adherence of tool material

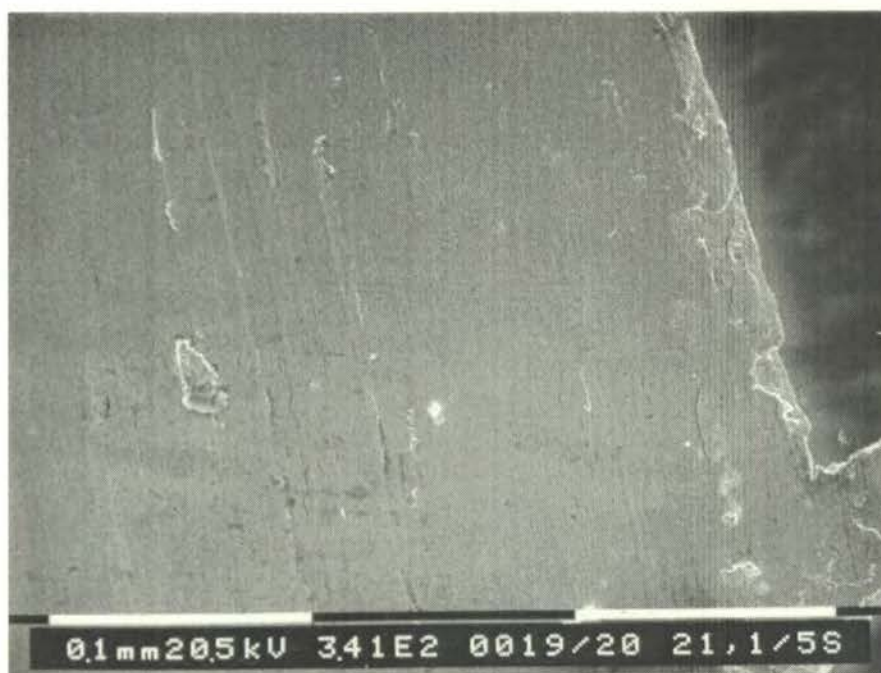
Figure 8. 5 (a) SEM micrograph showing stuck tool material to the root of a Waspaloy chip produced by KC994M tool after cutting for 5 seconds at 25 m/min and 0.08 mm/tooth. (b) Corresponding EDAX analysis proving the adherence of tool material to the chip

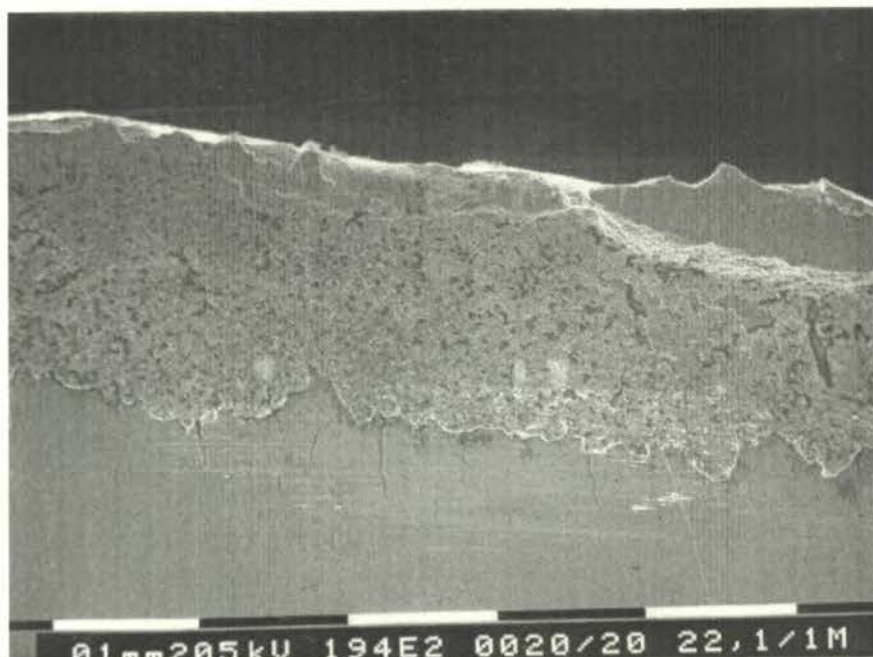
Figure 8. 6 (a) SEM micrograph showing stuck tool material to the root of a Waspaloy chip produced by KC720 tool after cutting for 1 minute at 25 m/min and 0.14 mm/tooth. (b) Corresponding EDAX analysis proving the presence of tool material on the back side of the chip

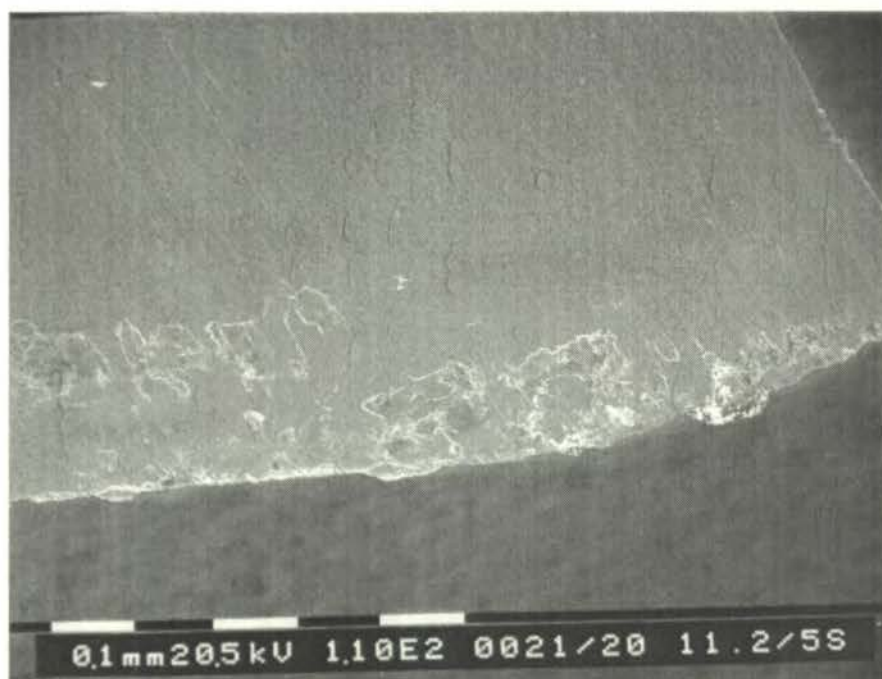
Figure 8. 10 SEM micrograph showing stuck tool material to the root of an Inconel 718 chip produced by KC720 tool after cutting for 5 seconds at 75 m/min and 0.14 mm/tooth.
 (b) Corresponding EDAX analysis showing the presence of tool material

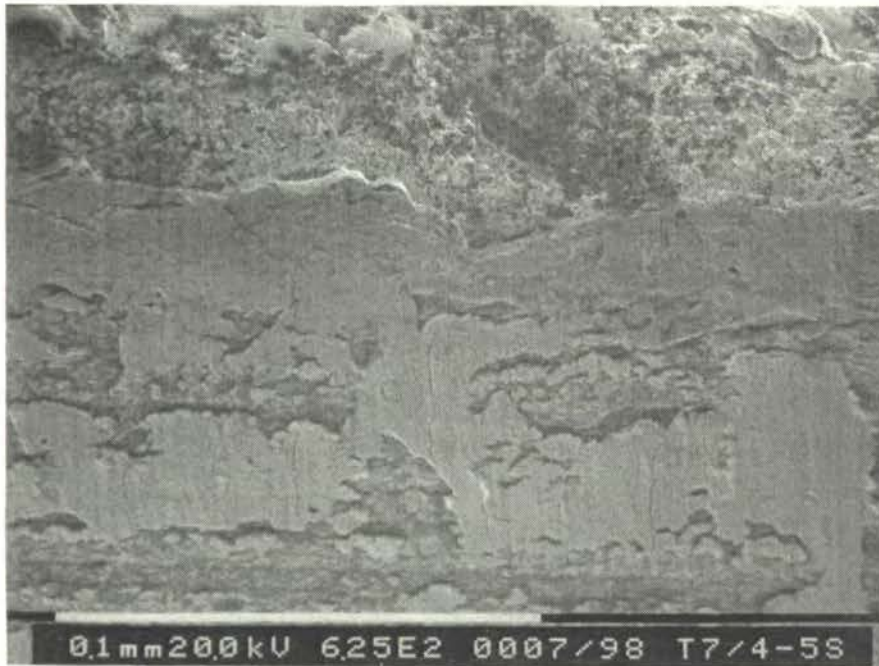
Figure 8. 17 Relatively intact coating on the flank face of a KC994M tool after cutting Inconel 718 for 5 seconds at 100 m/min and 0.08 mm/tooth.

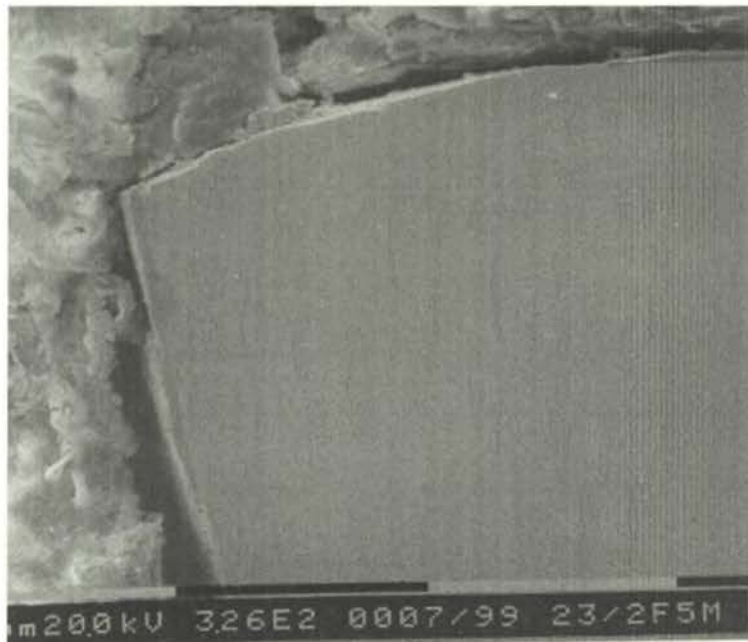
Figure 8. 20 Sectioned KC720 tool showing complete workpiece adhesion on the flank face after cutting Waspaloy for 5 minutes at 25 m/min and 0.08 mm/tooth.

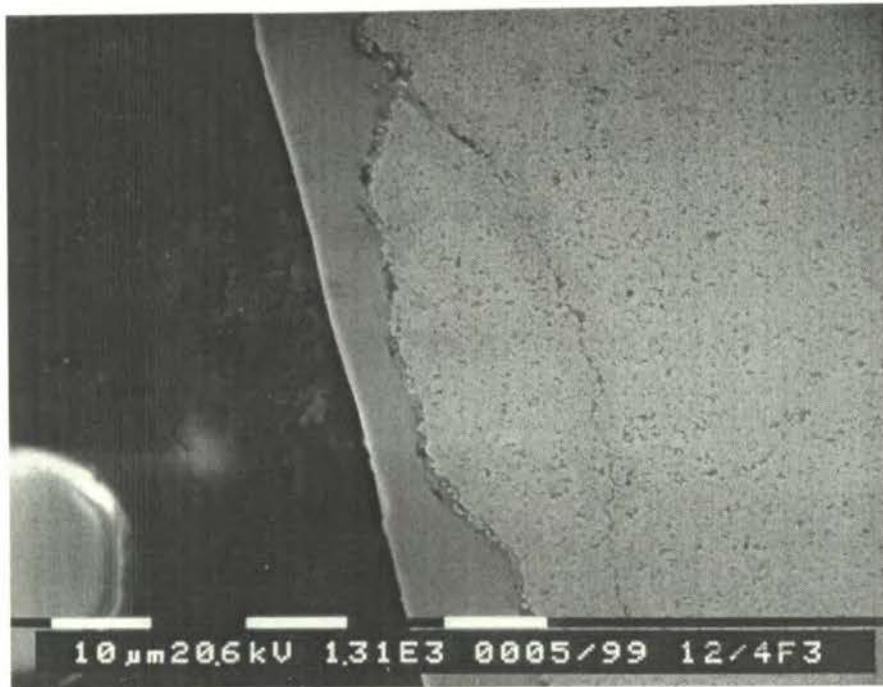
Figure 8. 23 Magnified view of Figure 8.21 showing evidence of strong adhesion of the workpiece over the fractured areas and detail of propagated crack with initiation point

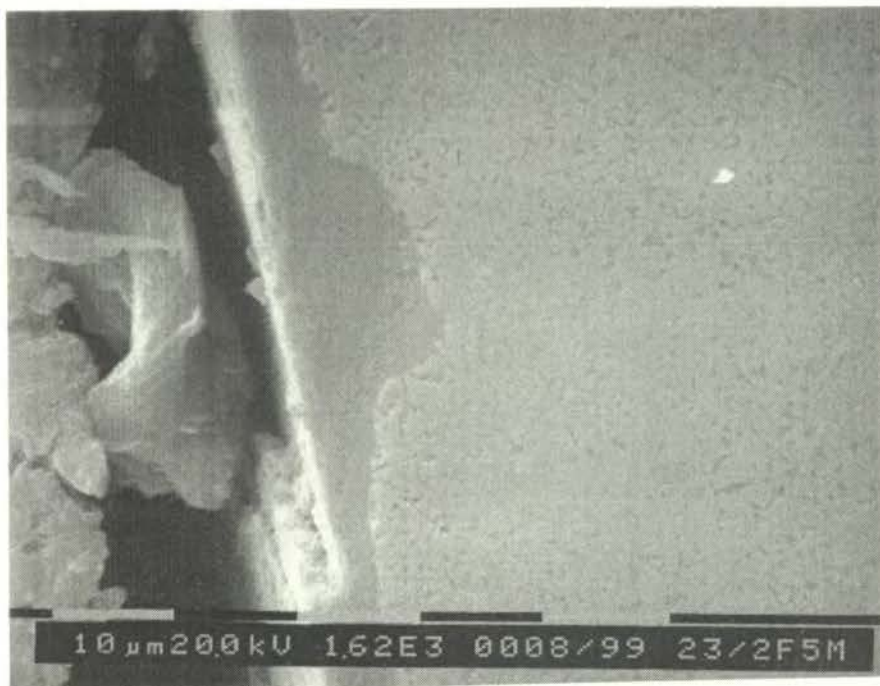
Figure 8. 24 Magnified view of Figure 8.20 showing strong workpiece adhesion over a fractured region on the flank face

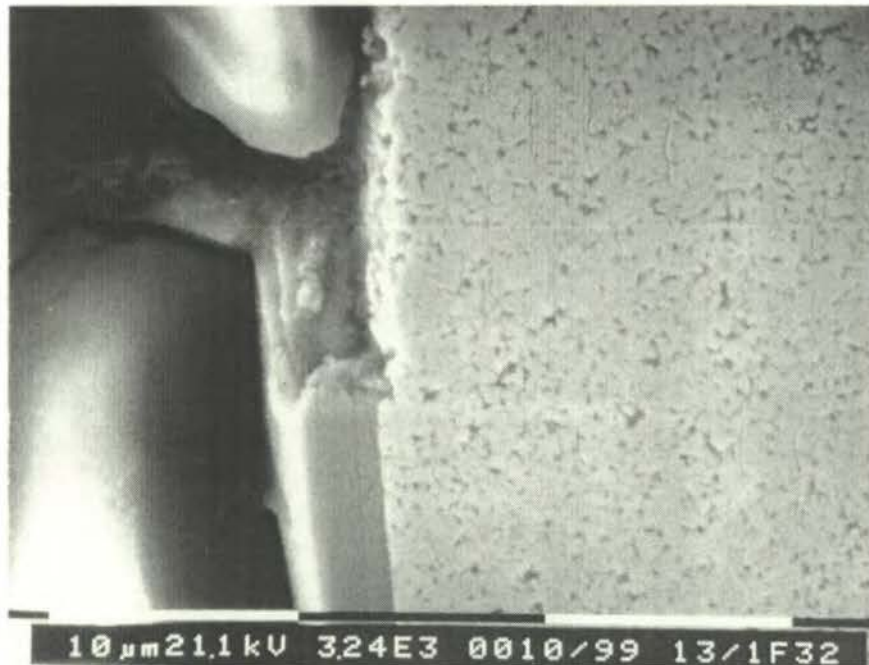
Figure 8. 26 Magnified view of a KMF tool showing strong workpiece adhesion over smoothly worn flank and suggesting attritional removal of tool grains due detachment of the adhered workpiece after cutting Inconel 718 for 32 minutes at 25 m/min and 0.08 mm/tooth.

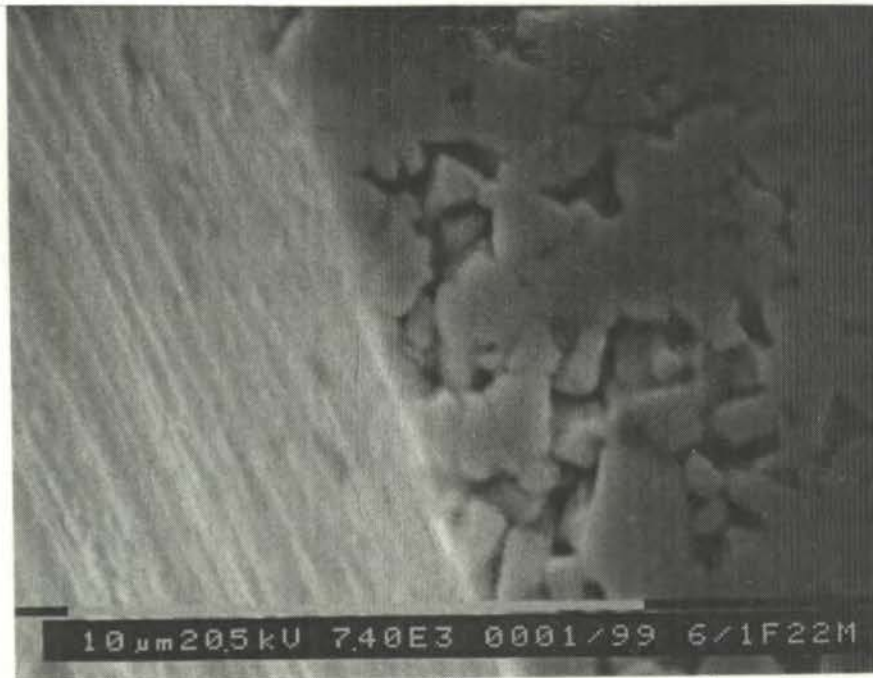
Figure 8. 27 Magnified view of a sectioned KC994M tool showing smoothly worn carbide grains on the flank face, suggesting the presence of abrasion/diffusion wear mechanism; after machining Inconel 718 for 22 minutes at 25 m/min and 0.14 mm/tooth.

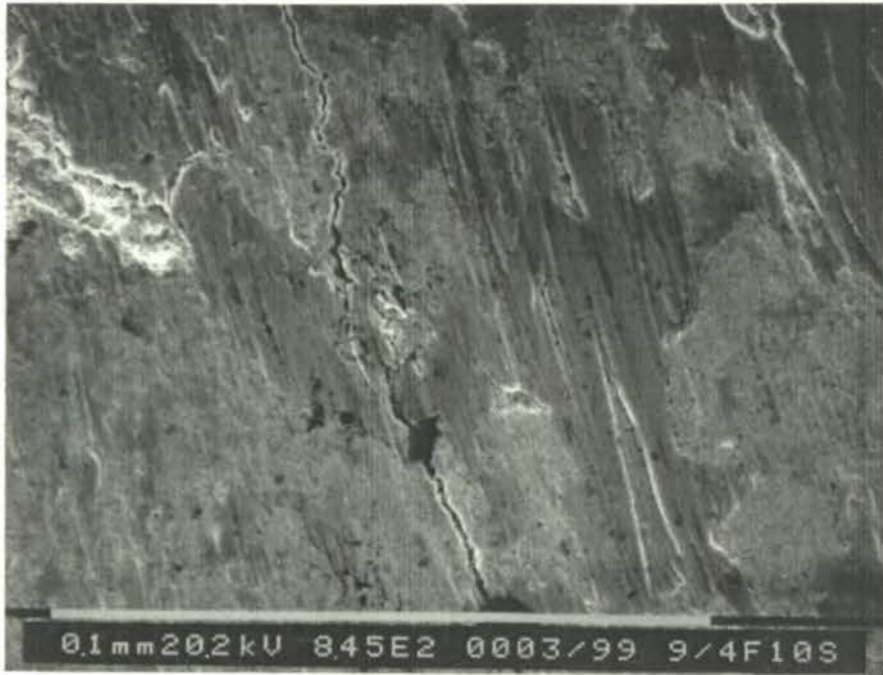
Figure 8. 29 Magnified view of the rake face of a KC720 tool showing crack and a smooth wear pattern indicating the presence of abrasion/diffusion mechanisms; after cutting Inconel 718 for 10 seconds at 100 m/min and 0.08 mm/tooth

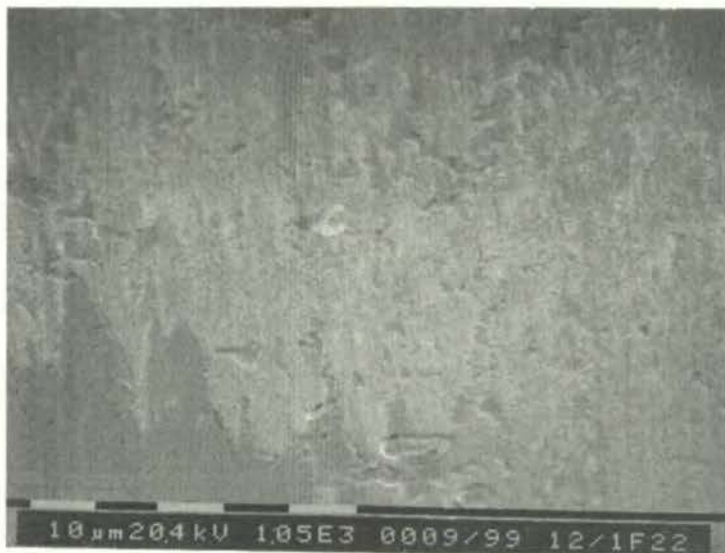
Figure 8. 30 Magnified view of the nose flank face of a KMF tool showing smooth wear pattern indicating the presence of abrasion/diffusion mechanisms; after cutting Inconel 718 for 22 minutes at 25 m/min and 0.08 mm/tooth

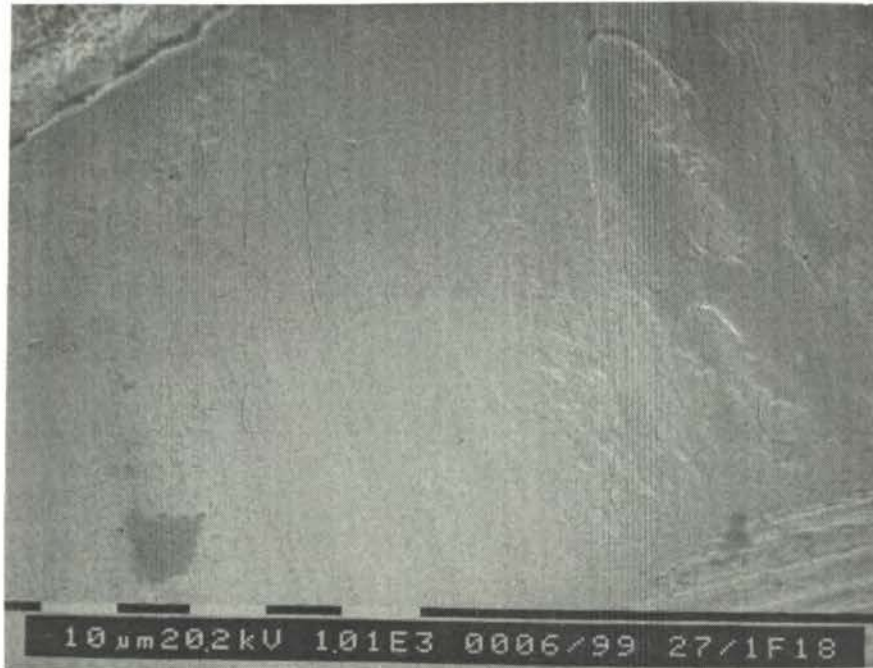
Figure 8. 31 Magnified view of the flank face of a KMF tool showing smooth wear pattern indicating the presence of abrasion/diffusion mechanisms; after cutting Waspaloy for 18 minutes at 25 m/min and 0.08 mm/tooth

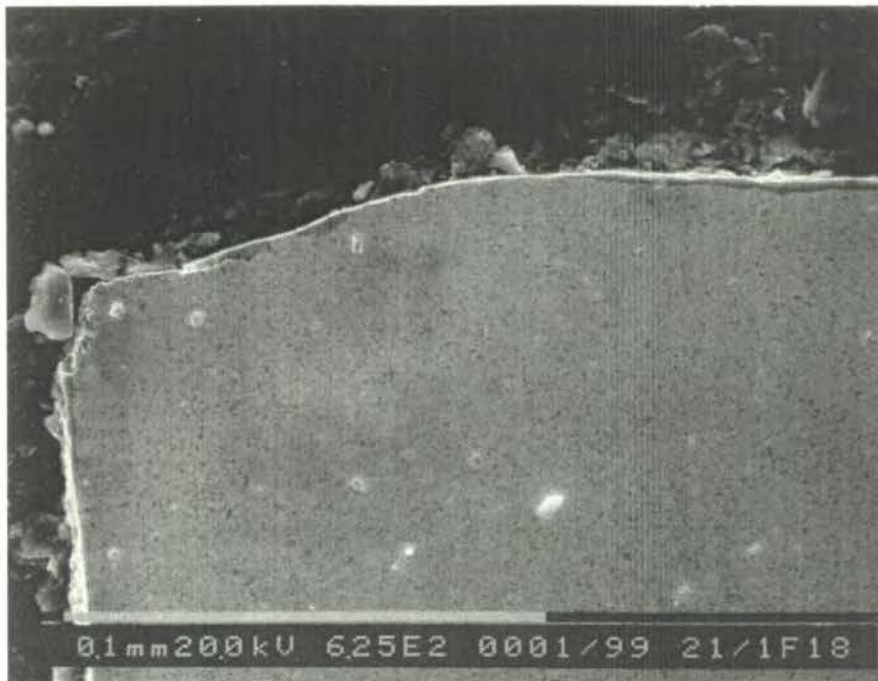
Figure 8. 32 Sectioned KC994M tool showing adhered workpiece on the rake and flank faces, plastic deformation of the rake face and a smoothly worn region on the lower flank after cutting Waspaloy for 18 minutes at 25 m/min and 0.08 mm/tooth

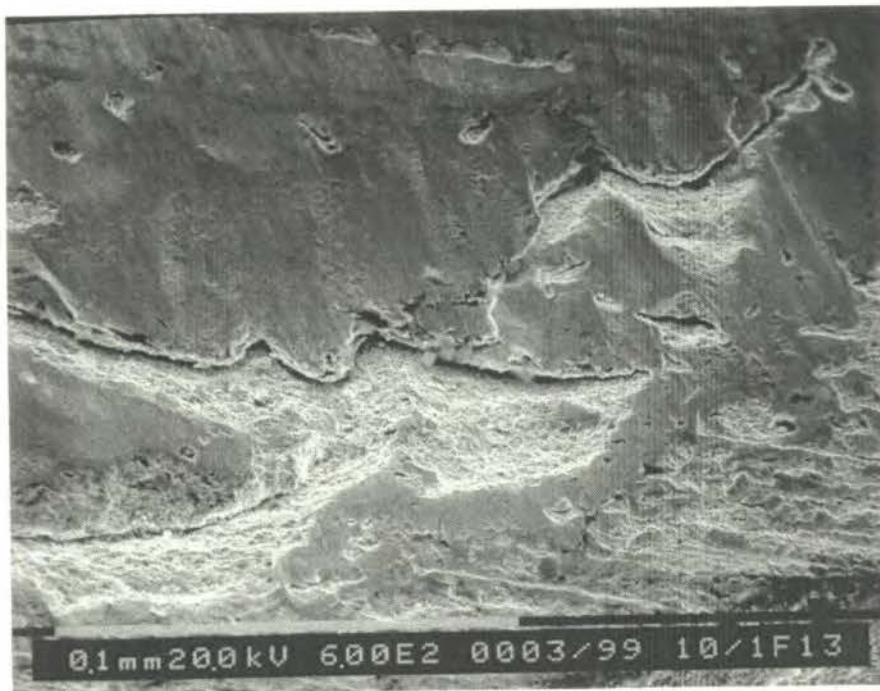
Figure 8. 36 Rake face with multiple cracks and galling of a KC730 tool which become highly susceptible to further plucking/fracture and crack propagation, after cutting Inconel 718 for 13 minutes at 25 m/min and 0.14 mm/tooth
